## **Prairie County Tornado Event May 20, 2011 National Weather Service Glasgow Storm Survey Summary**

# Public Information Statement Issued 5/22/2011

...FINAL DAMAGE SURVEY RESULTS FOR TORNADO SOUTH OF TERRY MONTANA...

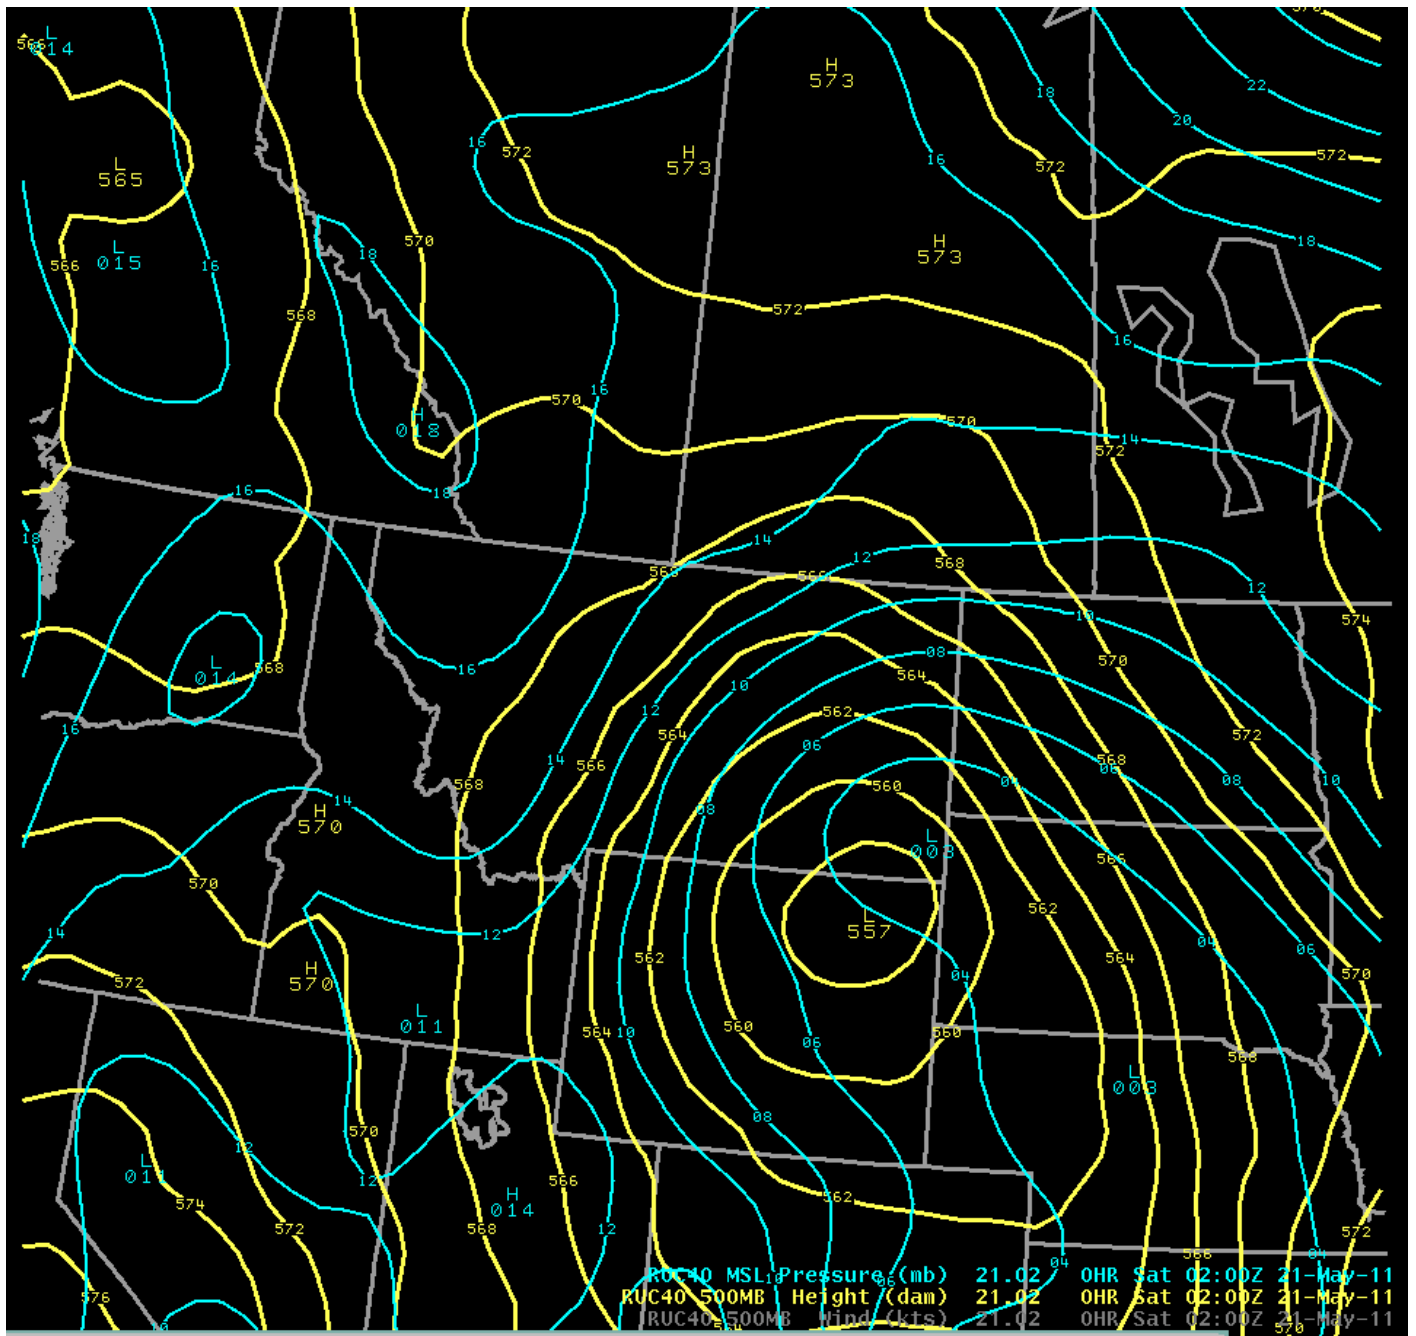
Fig. 9. 500mb heights and MSL Pressure at 2Z (8pm LT) from RUC40 analysis.

Figure 9 shows the 500mb heights (yellow) and surface MSL pressure (blue) contours at 0200 UTC (8pm local time) from the RUC40 analysis, about 30 minutes before the tornado. This shows a moderately strong midlevel closed low south of Eastern Montana, with a nearly stacked surface low over Southeastern Montana.

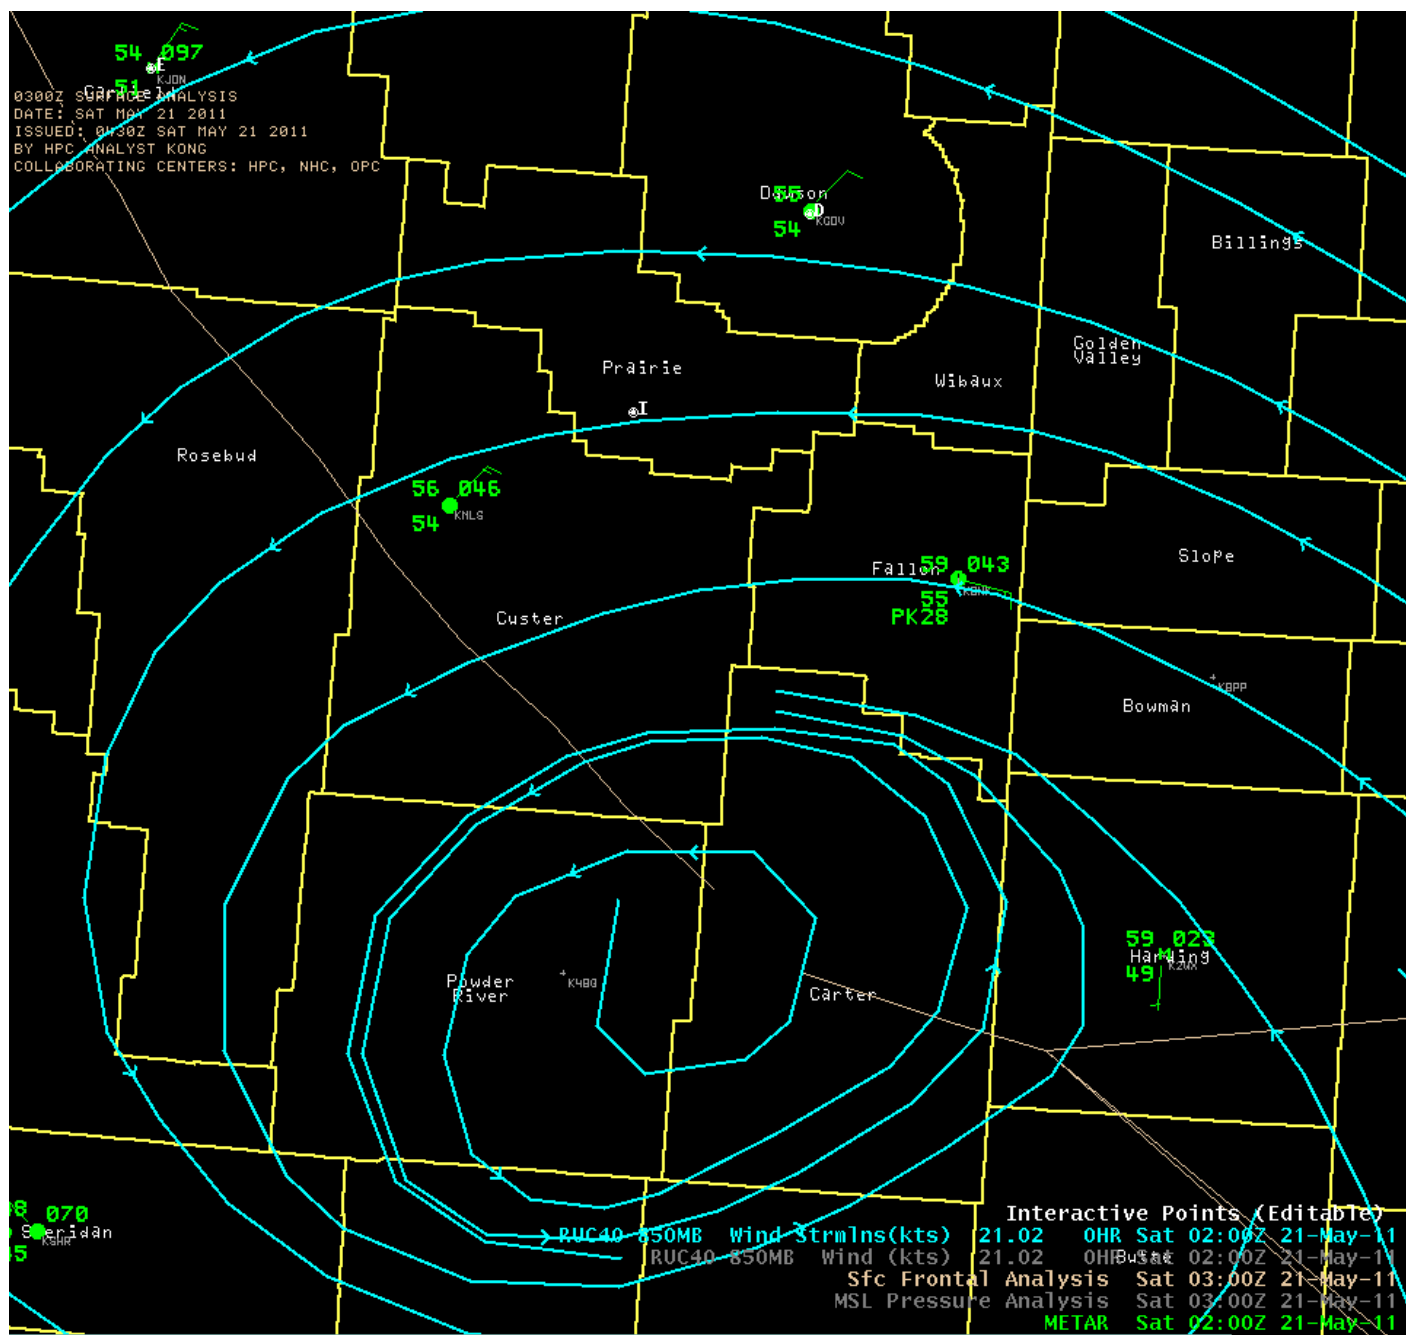
Fig. 10 850mb RUC40 streamlines, surface observations, and HPC frontal analysis for 8pm 5/20/11.

Figure 10 shows the 850mb streamlines (blue) from the RUC40 analysis for 8pm plus surface observations (green) and an HPC frontal analysis (brown). The analysis shows a warm front in the northwest sector of the surface low. The location of the tornado is indicated by plotting the letter “I” in white in Prairie County. At the time and location of the tornado, the surface flow was northeasterly on the north side of a strong surface low. Dewpoints were in the mid 50s, with temperatures also in the mid 50s.

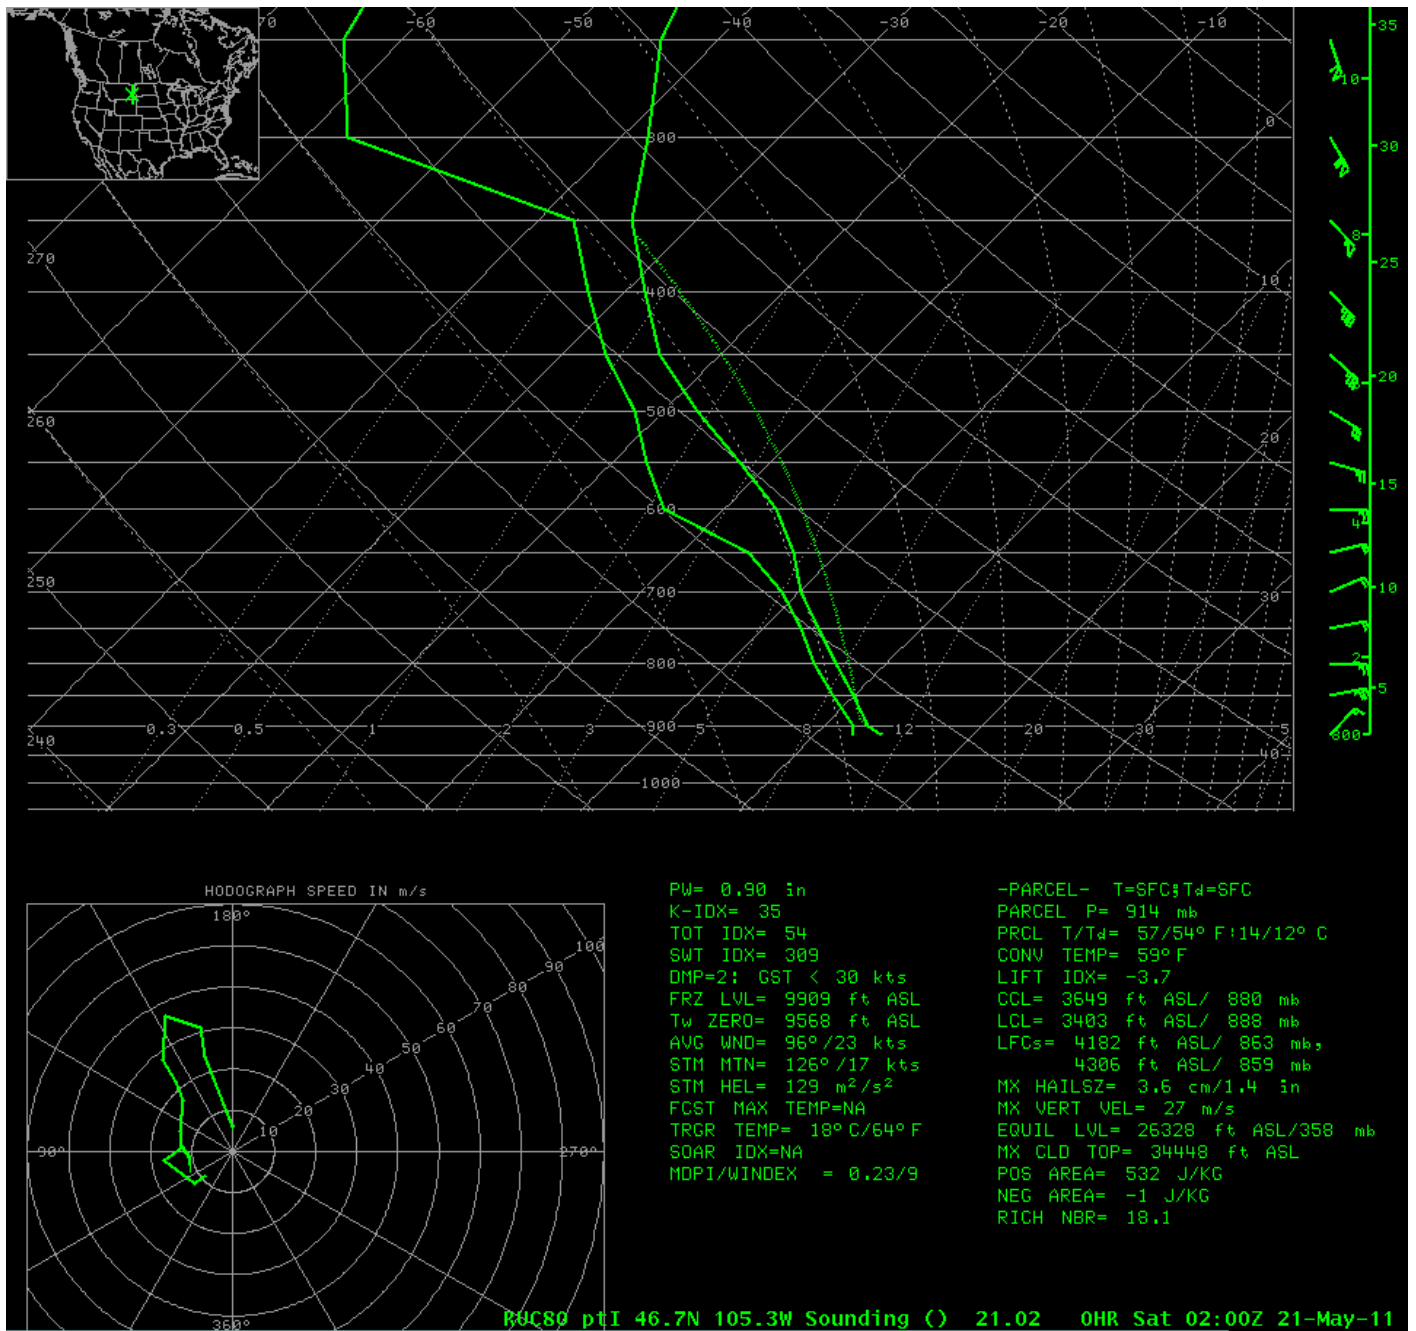
Fig. 11 RUC80 sounding for 8pm 5/20/11 at location of tornado.

Fig. 11 shows the RUC80 sounding analysis for the location of the tornado at 8pm. This shows a very moist and slightly unstable sounding with 532 J/kg of CAPE. Significant wind shear is also present with 60 kts southeasterly at 300 mb and 15 kts northeasterly at the surface. This sounding bears some resemblance to that for hurricane-spawned tornadoes.
